Safety Alert

U. S. Department of the Interior
Bureau of Safety and
Environmental Enforcement
Pacific OCS Region

Safety Alert No. 21
January 13, 2014

Pollution from Production Operations Due to Improper Diversion of Production Flow and Rupture Disc Failure

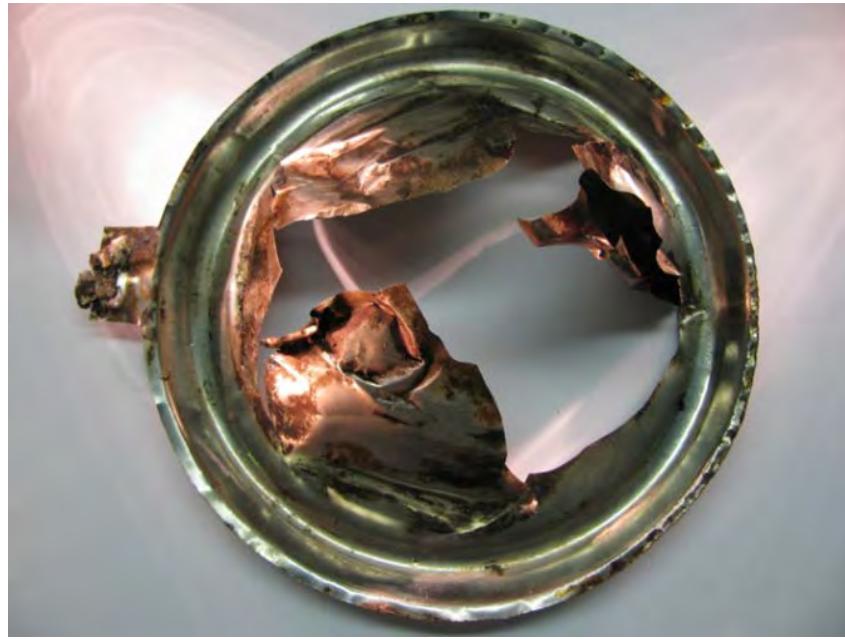
- The rupture of the PSE in the piping from the surge tank allowed the release of liquid hydrocarbons into the flare header. Based on the production volumes and normal operating pressure, it is believed that the PSE failed at a pressure well below its rated pressure. A laboratory analysis of the ruptured PSE (pictured below) indicated corrosion pitting, fatigue, and brittle cracking. There was no documentation indicating when the

PSE was installed or when, if ever, it had been replaced. It is possible that the PSE had been in service for more than 20 years.

Rupture Disc Recovered from Platform's Surge Tank (BSEE Photo)

- Maintenance, testing, and documentation procedures of PSEs and other safety devices are adequate to ensure those devices will perform as intended. Operators should check the status and condition of any PSEs or similar devices in use in their production systems. Operators should be especially aware of the age of such discs as well as the working conditions that the discs are subjected to, which may result in fatiguing or failure. The rupture disc marking identification tags should be attached and legible. Operators should inspect rupture discs for damage or pre-existing flaws before installing replacements.
