**Safety  
Alert**

Safety Alert No. 302  
2 July 2012

### **Pressure beneath a Surface Bridge Plug Blows Work String out of Well**

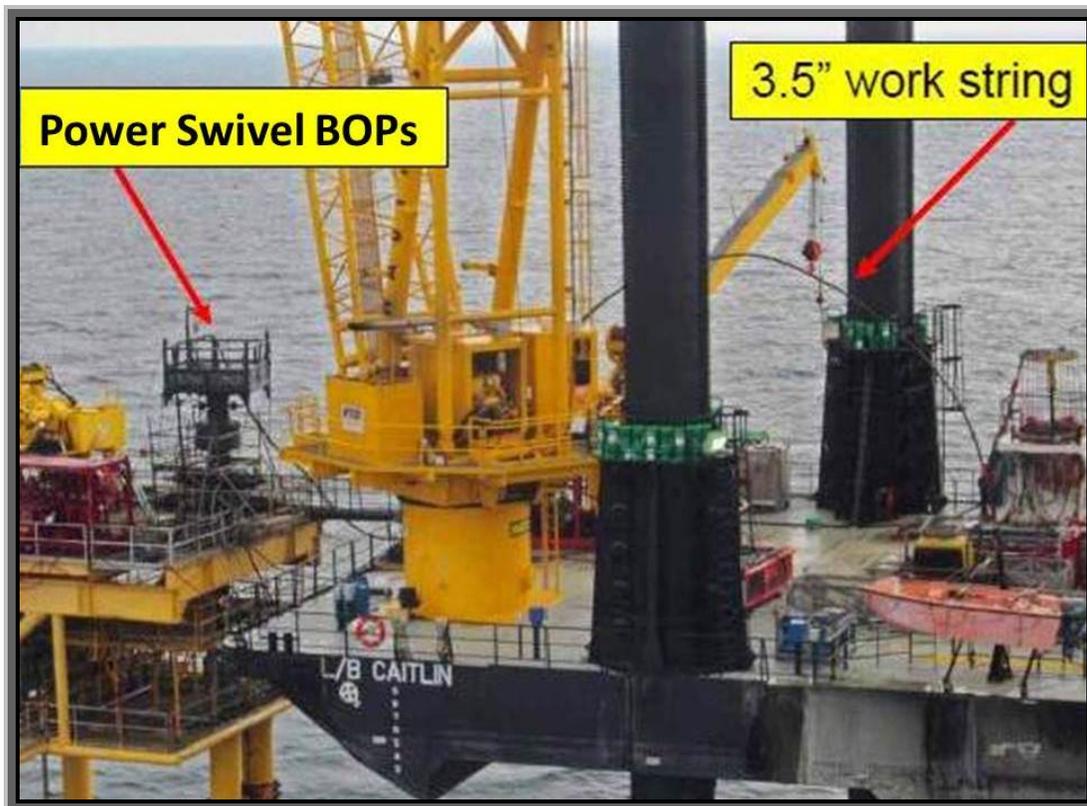
During the P&A operations, pressure encountered below the bridge plug ejected 385-feet of work string and the bottom-hole assembly out of the wellbore before the blind shear rams of the BOP sealed the well. A portion of the ejected bottom-hole assembly struck a diesel tank and released approximately 5-gallons of diesel into the Gulf. In conjunction with sealing off the well with the BOP, the crew activated the emergency shut-down device for the platform which functioned properly.

- Upon re-entering the well on May 15, 2012, the Operator found 100 psi sustained pressure on the 11 7/8-inch by 16-inch annulus;
- The Operator did not take additional precautions, such as, conducting a hazard analysis for potential pressure below the plug;
- There was no indication of a pressure build up below the bridge plug until the 200-feet of cement was drilled out and the bridge plug penetrated.

BSEE recommends Operators review their procedures for re-entering wells with sustained casing pressure. In such cases, Operators should modify operational plans to take into account the likelihood of well-bore pressure beneath plugs. Based on a case-by-case basis, consider using coiled tubing, snubbing unit and/or a workover rig.
