Safety Alert

Safety Alert No. 306 19 March 2014 Contact: Matt Nagy (504) 736-2828

Trapped Pressure Beneath a Tubing Plug Blows Work String from Well

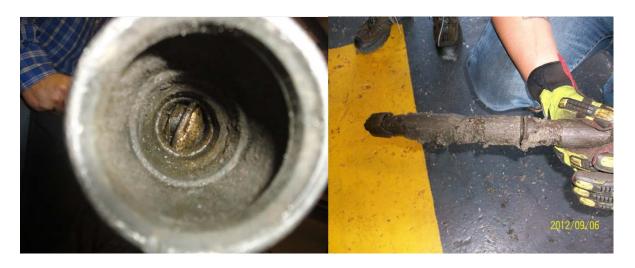
- Wireline jet-cutter debris and sand had accumulated on top of and inside the plug body and the equalizing sub-assembly directly beneath the plug. The presence of the debris and sand prevented the fluid from being pumped through the plug and into the formation to kill the well.
- The wireline jet-cutter debris and sand made it unlikely that the equalizing ports on the plug would open, thus preventing the identification of trapped pressure below the plug.
- The lease operator made the decision to cut the tubing below the plug with some uncertainty as to the presence of pressure trapped below the plug.

- Diagnostics be thoroughly performed on wells prior to re-entry to check for trapped pressures.
- Operators develop operational procedures that account for the possibility of trapped pressure beneath previously set plugs.
- Consideration of using snubbing units for well servicing when there is any doubt as to the presence of pressure below plugs of any type.
