Lower Stairwell Step Collapses Causing Injury

--BSEE--GOMR--
www.gomr.BSEE.gov

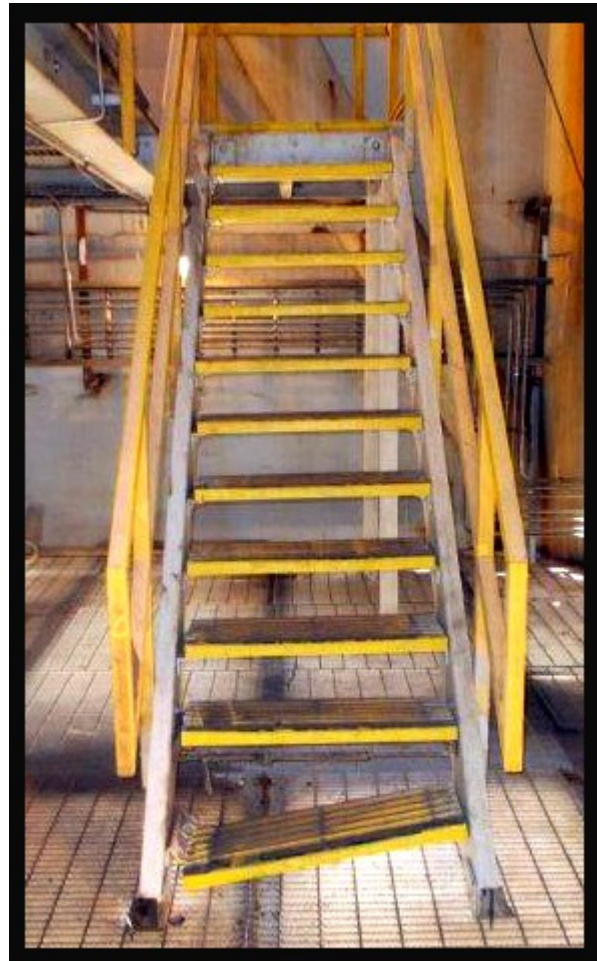
An injury occurred when a contract employee was descending the mezzanine well deck area heading to the lower second deck. When the Injured Person (IP) reached the last step, the fiberglass bracing of the metal step collapsed causing the worker to fall to the deck and injure his knee.

A BSEE investigation revealed the following for the fiberglass bracing:

- The bracing supporting the step may have exceeded the manufacturer's 20-year life expectancy.
- The bracing may have deteriorated due to periodic exposure to chemicals or prolonged exposure to weather or excessive vibration.
- Unless inspected closely, the bracing appeared to be in good condition.

- Replaced the fiberglass bracing with more durable aluminum supports.
- Added diagonal and cross bracing for additional strength and support.
- Installed J-bolts to secure stairway to lower grating deck.
- Inspected similar construction on all associated facilities to verify the safety of the step bracing of all stairwells.

- Inspect all stairwells to determine the type of bracing that supports the steps.
- Install and maintain all fiberglass bracing as per the manufacturer's installation and maintenance recommendations.
- Schedule periodic maintenance to ensure adherence to manufacturer's recommendations with regard to fiberglass bracing.
- Take specific precautions to aging fiberglass bracing construction nearing the manufacturer's replacement recommendations.
