**BSEE****U.S. Department of the Interior  
Bureau of Safety and  
Environmental Enforcement****Safety  
Alert**Safety Alert No. 308  
19 March 2014Contact: Matt Nagy  
(504) 736-2828

## Overloading Leads to Catastrophic Failure of Crane Boom

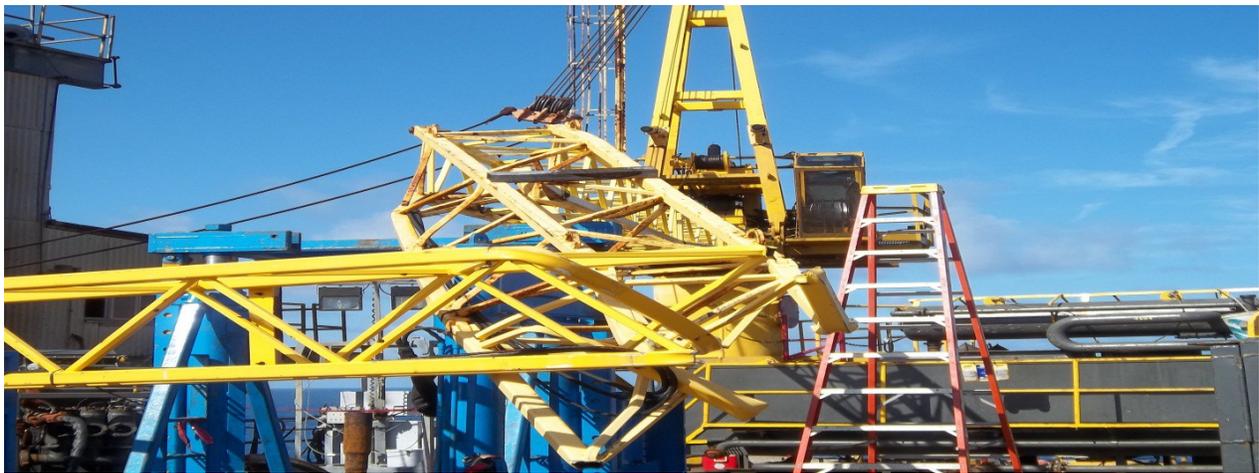
A lease operator was performing a well permanent abandonment (PA) on an Outer Continental Shelf (OCS) platform. Operations were being conducted to pull the 3.5" workstring and casing knives from the well after using a power swivel to cut the 9<sup>5/8</sup>" and 10<sup>3/4</sup>" casings. The cutter assembly had become stuck while mechanically cutting the casings, and the hydraulic cylinders on the swivel stand were used to free the stuck knives. The cutter came free from the casing and the assembly was ready to be pulled from the well using the crane. The workstring and knives weigh approx. 6,600 pounds. The load line on the platform crane was attached to the workstring using pipe elevators. The load chart in the crane indicated that the crane could perform a static lift of 21,448 pounds and dynamic lift of 16,780 pounds at a boom angle of 63 degrees. The boom was raised to a 63 degree angle and the crane operator then proceeded to pull on the workstring until 21,000 pounds was displayed on the weight indicator with no success. The crane operator stated "looked like workstring was stuck." After slacking off on the load, a second attempt was made to pull the workstring and knives from the well. The crane operator stated that "the weight indicator in the crane cab was displaying 21,000 pounds during the second attempt." The operator then stated that "all of the weight fell off of the indicator at which time the crane boom began to fall to the deck of the platform." The crane boom, as well as a power pack, came to rest on the power swivel stand that had been used for the cutting operation. The tip section of

the boom came to rest at approximately 90 degrees to the right side of the main stem of the crane boom. No personnel were injured, and all were accounted for immediately following the incident.

- Incorrect load chart was used at the time of the incident.
- The crane operator used static load limits when pulling cutter assembly from the well instead of using the dynamic load limits as required by the contractor's SOP.
- The bore holes of the pin connections in the boom showed excess wear thus causing slack in the connections and improper load distribution in the boom.
- The diagonal lacing, boom cords, and pin connections of the middle boom sections were found to be corroded.

- Conduct proper crane pre-use inspections as per API RP 2D, C.4.1.2a which should include proper load chart verification.
- Conduct proper crane maintenance inspections as per API RP 2D, C.4.1.2 which should include thorough inspection of boom connections and proper load chart verification.
- Adherence to the SOPs and procedures put forth by both the operator and contractor while conducting lifting operations.
- Use the load chart for the dynamic load limits when pulling tubulars from wells instead of using the static load limits.
- The Crane Operator shall verify that the hook load is within the crane's applicable static or dynamic rated load at the radius for which the load is to be lifted.
- Crane boom pull shall never exceed the calculated weight of the hook load, block, and rigging.
