SAFETY ALERT

Safety Alert No. 335
14 May 2018

Failure to Mitigate Known Hazards Leads to Kick

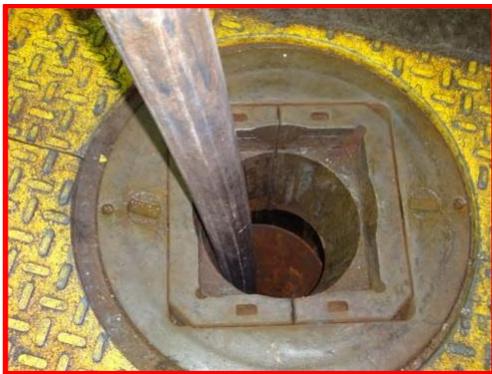
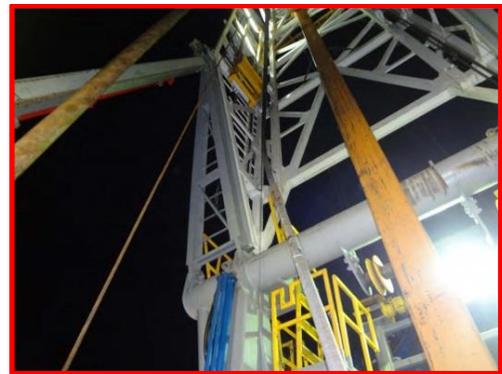
Buckled pipe leans against rotary table (left) and derrick (right) after being ejected from well

The incident investigation found the immediate cause to be pressure below the bridge plug, which exceeded the weight of the work string, consequently forcing the pipe out of the hole. There were multiple contributing factors that could have prevented the incident from occurring:

- A pre-job assessment was completed and presented during the program kickoff meeting. Despite identifying the risk of gas beneath the bridge plug, a pilot mill to mitigate the risk was not used.
- Uncertainty around milling large bridge plugs at shallow depths, as well as encountering gas below bridge plugs were discussed at the pre-spud meeting, yet no mitigation techniques were included in the well program or communicated to the field outside of being aware of the possible hazard.
- The Job Safety Analysis recognized possible hazards related to gas below the plug, yet no recommendations were provided to eliminate or reduce the likelihood of these potential hazards.

- Ensure that completed hazards analysis and mitigations for the recognized hazards are communicated to the personnel conducting the operation.
- Reinforce with personnel that a Job Safety Analysis should not only identify potential hazards, but should provide mitigations to reduce or eliminate the risks identified.
- Employ methods to identify and safely relieve trapped pressure on the backside of any well barriers prior to releasing a barrier latching mechanism or slips.
