Safety Alert No. 311
1 May 2014

Methane Venting Hazard to Helicopter Operations

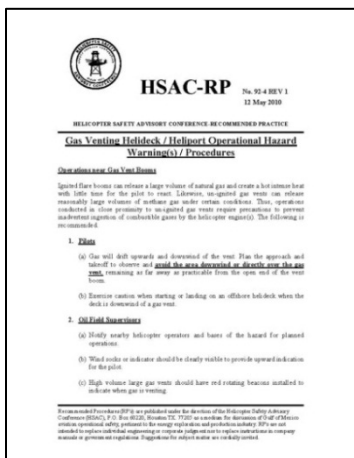
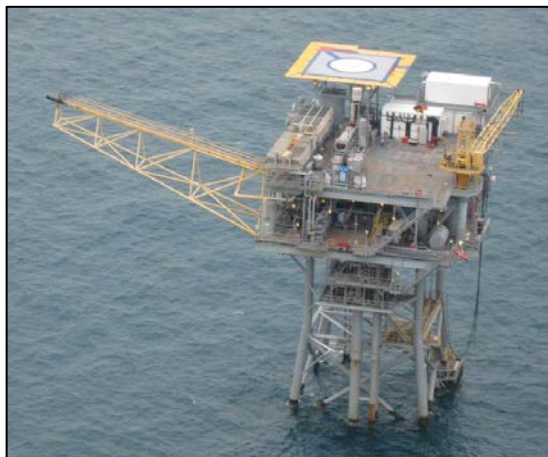
When vented, it can drift over the helideck where it can be ingested by the engine and act as unmetered fuel potentially causing the engine to overspeed or fail. For this reason offshore facilities generally place methane booms as far away from helidecks as practical.

BSEE recommends that helicopter companies, pilots, and offshore Oil and Gas Operators thoroughly review and adhere to the guidance provided in HSAC RP 92-4 and company policies. Remember, these mitigation measures will minimize, but not eliminate, the hazards posed by vented methane.
