Safety Alert No. 329
20 February 2018

Potentially Catastrophic Crane and Lifting Incidents

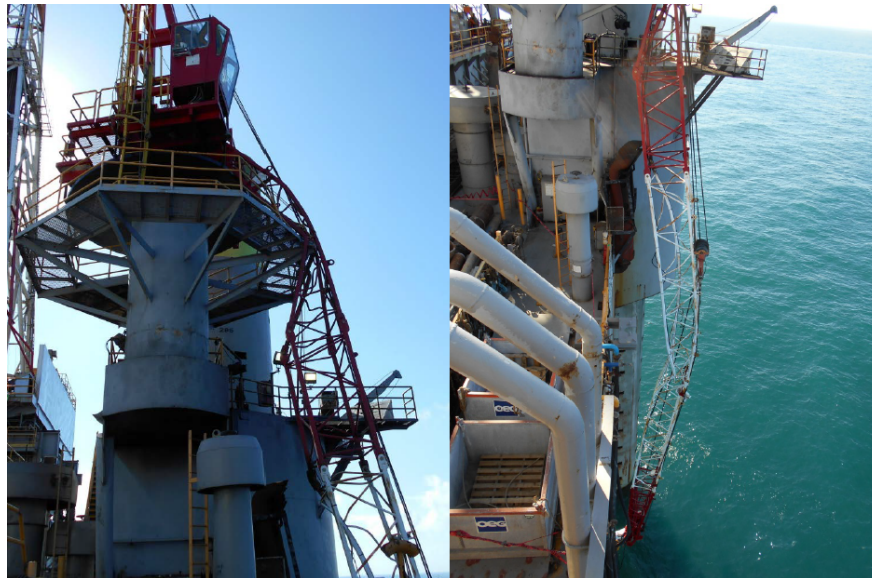
Crane boom hanging over the side of drilling rig associated with 29 November 2017 incident

- 29 November 2017: Immediately after completing a four-person personnel transfer, workers were preparing to hook up a pallet from a crew boat. The port crane boom fell freely hitting the side of the jack-up rig, puncturing a hole in the port diesel tank. The cause of the failure was missing retaining rings that held the pawl pin in place, causing the pin to dislodge. Inspection of the starboard crane also revealed missing retaining rings. Thirty eight barrels of diesel fuel was released into the Gulf of Mexico as a result of this incident.

- Review the mechanical integrity program to verify that crane maintenance and inspections are being performed per the Operator's SEMS plan, BSEE regulations and API RP 2D. The frequency of inspections and test must meet the manufacturer's recommendations. Special consideration should be given to:

- accessibility and inspection of a crane's boom hoist lock pawl cylinder assembly;
 - outer diameter measurements of boom, main, auxiliary and pendant cables;

- documentation on installation date, manufacture date and identification information for boom, main, auxiliary and pendant cables;
 - inspection and lubrication of sheaves; and,

- ensuring that wire rope size and sheave sizes are compatible.
- Verify that loads are centered, balanced and secured prior to initiating lifts.
