SAFETY ALERT

Safety Alert No. 317
12 June 2015

CATASTROPHIC INCIDENT AVOIDED

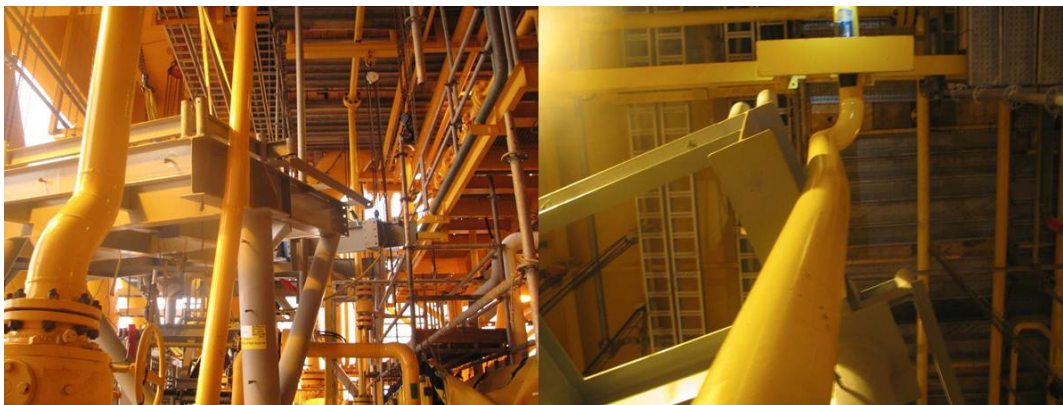
During the installation of a gas lift mezzanine deck on a deep water floating facility, the 6,500 pound structure shifted unexpectedly. This shift caused the load to jam between an existing, high pressure gas lift piping and a 4-inch valve, damaging the still-pressurized gas line and gouging the 4-inch valve body. In a subsequent attempt to free the active gas lift piping, the lifting crew performed a cold cut on a U-bolt brace without a change request or permits to work. A rupture of the line or valve could have led to a significant gas release, fire and/or explosion. The Offshore Installation Manager (OIM) averted disaster by stopping the job during a regular inspection walk on the platform.

Deck against Gas-Lift Line

Bowed Gas-Lift Line

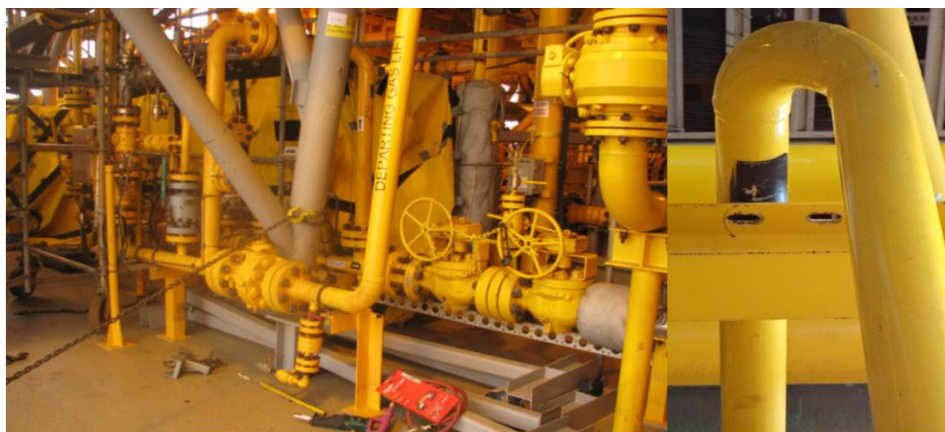
Deck Jammed Between Gas-Lift Line

U-bolt Cut

- Changes were made during the work activity (e.g. cutting the U-bolt brace) without first analyzing the potential hazards or notifying other personnel onboard the facility.
