Safety Alert

U.S. Department of the Interior
Minerals Management Service
Gulf of Mexico OCS Region

Safety Alert No. 278
7 April 2009

One Killed when Oil Pollution Pan Falls

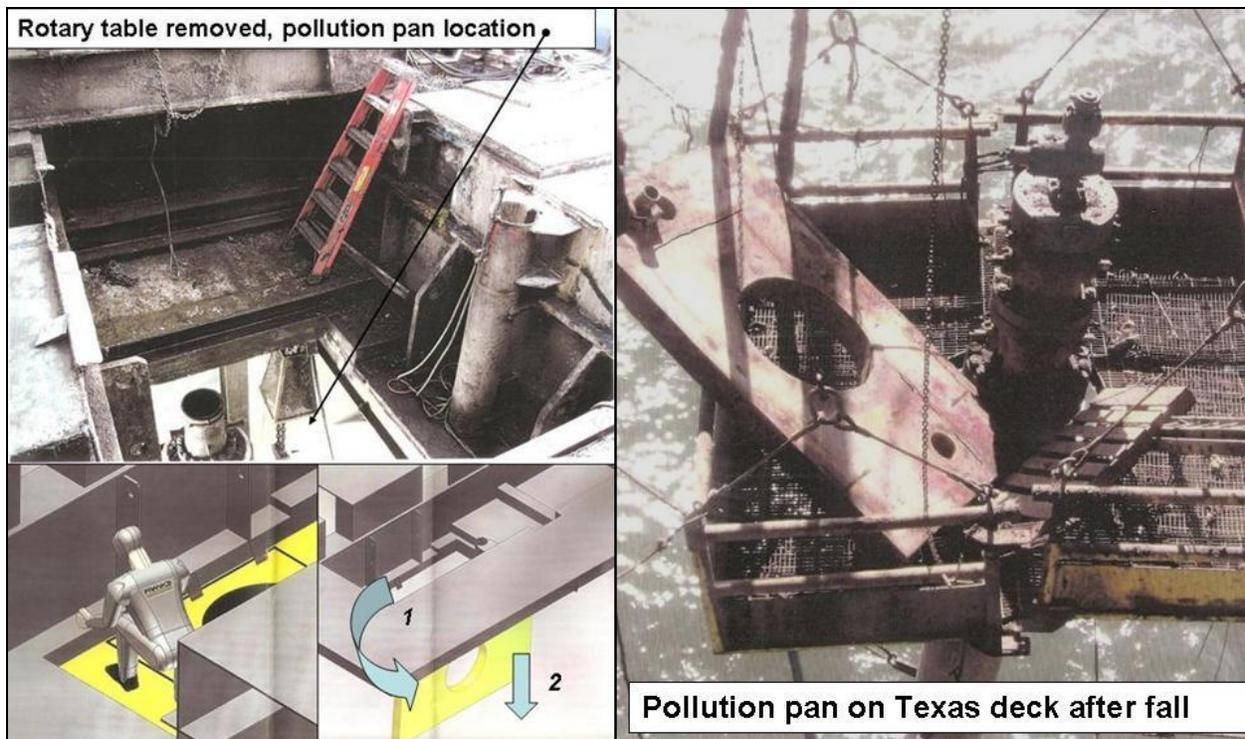
In a recent incident on a drilling rig a casing crew was rigging up to run 60-inch over-drive pipe. Two welders were cutting a hole in the pollution pan beneath the rotary when the pan suddenly dropped out from beneath them and fell 50-ft to the Texas deck. One of the welders fell with the pan and was killed.

An investigation discovered that the oil pollution pan was only attached to the rig by 3-inch metal straps, not hard-welded or bolted to the rig sub-structure. These straps were cut by the welders in the course of their work, which allowed the pan to fall out from beneath them.

1. *Rig OIMs and supervisors should review how oil pollution pans are attached to their rig. Contract supervisors should conduct a thorough review of the parameters of their tasks prior to starting work.*
