# Safety Alert

U.S. Department of the Interior  
Bureau of Ocean Energy Management,  
Regulation and Enforcement  
Gulf of Mexico OCS Region

Safety Alert No. 296  
12 May 2011

## Catastrophic Failures in Mooring Systems Possibly Put Floating Structures at Risk

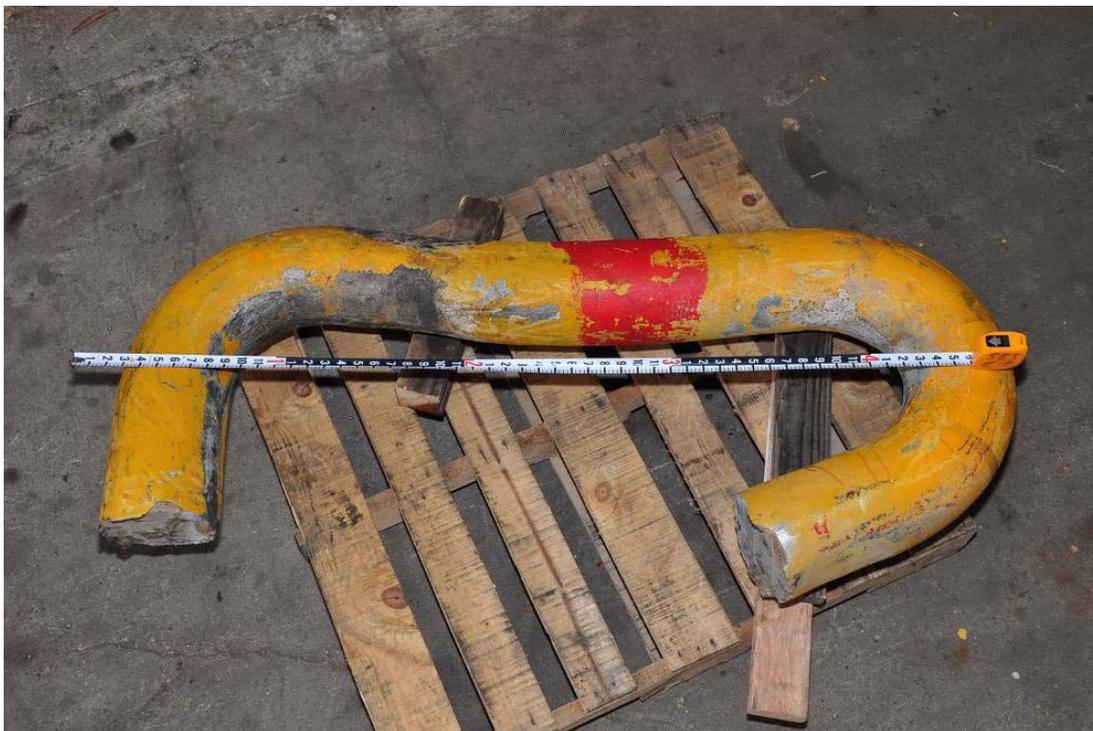
**Failed Chain Link**

The investigation determined that a 6 3/4-inch diameter, 862-pound chain link in the tether chain had fractured and separated near its butt weld. Analysis of the fracture indicated that the chain link had a weld repair and the fracture initiated in the middle of the weld. Three links of the 24-link tether chain were found to have weld repairs. After the chain had been heat treated, the non-US based manufacturer had made weld repairs to the chain by grinding defects and filling the void with weld material. The chain was being built in accordance with Det Norske Veritas (DNV) Offshore Mooring Chain standard. Post heat treat weld repairs are disallowed per DNV's Offshore Mooring Chain standard. The post heat treat weld repairs made the chain susceptible to hydrogen induced stress cracking due to the extreme hardness

of the weld material and the residual stress within the weld.

- **Operators** should monitor and inspect critical mooring components 100% of the time during the manufacturing process.
- **Operators** should ensure that the personnel and companies contracted to perform inspections and quality assurance of critical mooring components are qualified to do so.
- **Operators** should treat the area above a buoyancy air can for a free-standing hybrid riser as potentially hazardous. No floating production facility or support vessel should be allowed to pass over a free-standing hybrid riser.

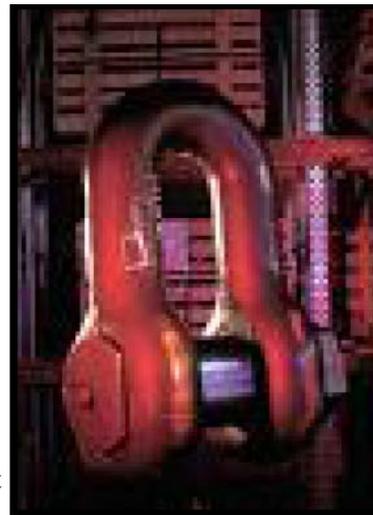
**Example: Mooring Shackle**

**Incident No. 1:** A one-ton, 8+ inch-diameter shackle connecting a mooring system to anchoring pilings failed on an overseas floating production facility. Subsequently, an identical shackle scheduled to be used in a deepwater GOM production facility also failed catastrophically under test loads below specifications. Operator reviews of the manufacturing and testing procedure and additional material testing indicated that all of the shackles were possibly defective.

Because anchor pilings with shackles attached had already been driven, the GOM test failure required new shackles to be manufactured, new pilings installed and the replacement of portions of the mooring systems that could not be recovered. Production start-up of the facility has been delayed by at least one year.

- In both cases the manufacturing procedures are thought to have been defective. Heat treating after casting apparently resulted in a metal unable to meet “Charpy” standards for material “toughness.”
- In both cases, the Operator’s and/or manufacturer’s specifications for the items were either out of date or inadequate.
- In both cases the Operator’s material testing requirements were either not followed, or were not adequate to insure specifications were met.
- Material handling during installation may have exposed the equipment to potential critical damage.

- **Operators** should review their specifications requirements to insure testing and manufacturing produces a product that will meet the usage demands.
- **Operators** should include sufficient *Charpy testing requirements* in the specifications to insure the materials and manufacturing process will produce a product of sufficient toughness.
- **Operators** should review their requirements for both destructive and non-destructive testing of critical elements. Operators should insure their test coupons are properly representative.
- **Operators** should review their requirements for equipment inspection and handling to insure no damaging techniques are employed in transportation or installation.

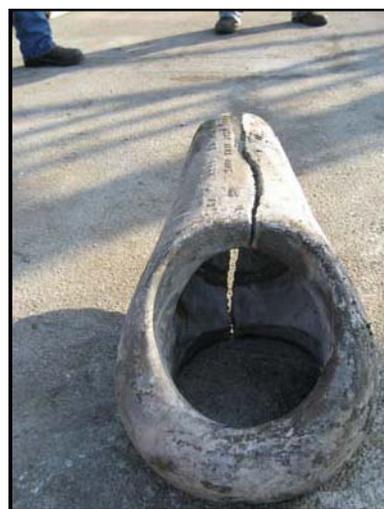
**Failed Mooring Socket**

**Incident No. 2:** Two sockets in a mooring system for a MODU failed under moderate loading. Testing of the remaining sockets found that others were also defective and a number of them failed catastrophically at less than specification loading.
