Safety Alert

Safety Alert No. 303
29 January 2013

Lower Marine Riser Package (LMRP) Connector Failure

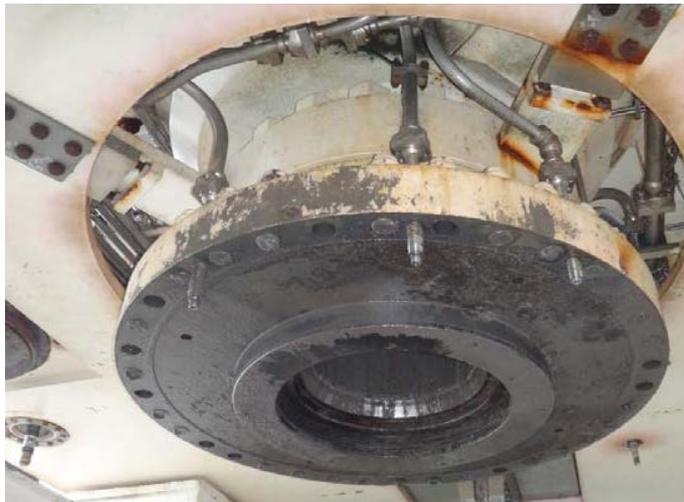
On January 24, 2013, BSEE personnel met with industry to discuss initial findings associated with a pollution incident involving the discharge of synthetic base mud (SBM) into the Gulf of Mexico (GOM) due to a loss of integrity of a LMRP H-4 connector. During this meeting, a qualified third-party presented preliminary evidence that the stress corrosion cracking caused by hydrogen embrittlement was a contributor to the incident. It was introduced that zinc electroplating without proper baking, as per ASTM B633, was a possible cause of hydrogen embrittlement. During this meeting, BSEE was informed of two other rigs as having H-4 connector bolt failures.

Upper half of failed LMRP Connector

Operators are hereby urged to make an inventory of your contracted rigs [currently involved in well operations in the Gulf of Mexico Outer Continental Shelf (GOM) or planned to conduct well operations in the GOM] and investigate the bolts of the LMRP and Wellhead connectors. For detailed instructions on identifying affected bolts please refer to the Safety Notice issued by GE Oil and Gas on January 25, 2013, titled, "H4 Connector Bolt Inspection Required(P/N H10004-2)" at the following: <http://www.ge-energy.com/connector-update.jsp>

BSEE. You should also consult with your contractors and subcontractors to determine the appropriate inspection, disposition and/or corrective actions. BSEE will require an independent third-party certification that confirms proper inspection and refurbishment processes were completed prior to reinstallation of any affected bolts.

Operators should review the QA/QC programs for all equipment vendors (contracted and sub-contracted) to ensure that all equipment is being manufactured to the required specifications. Special attention should be given to ensure proper heat treating has taken place in accordance with the specifications.

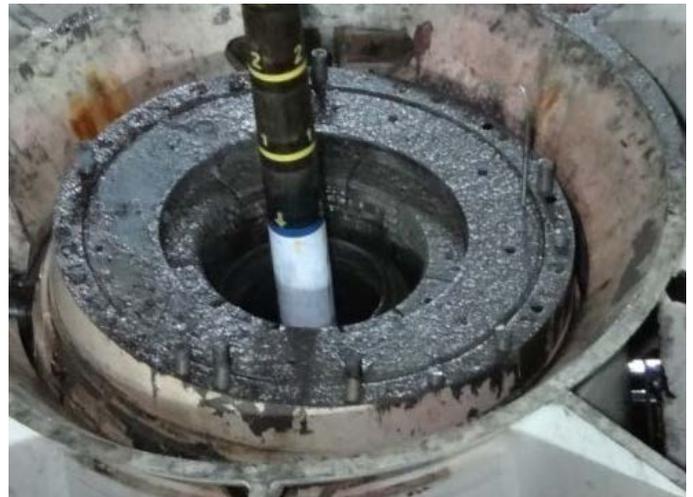
Lower half of failed LMRP Connector
