SAFETY ALERT

Safety Alert No. 324
April 6, 2017

Serious Incidents Associated with Pipe Racking Systems

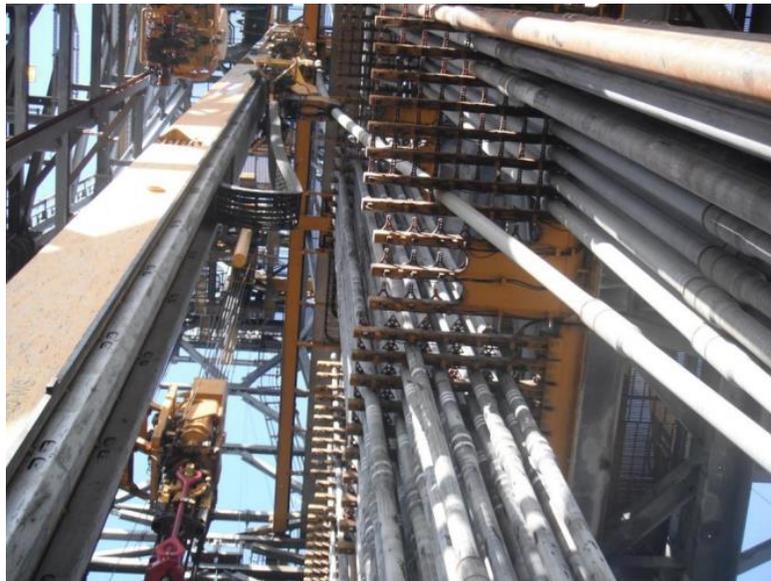
Multiple safety incidents have occurred with rig automatic pipe racking systems. These incidents involved failures of fingerboard latches and guide head claws to open or close properly. The failures allowed unsecured pipe stands to become potentially lethal hazards.

Therefore, BSEE recommends that operators perform a full inspection of their automatic pipe racking system before using the equipment on their next well. BSEE encourages the operators to:

- Installing sensors on guide head claws with a type of interactive software that allows operators to verify claw position at a control panel and automatically prevents movement of the guide head when guide head claws are not in the correct position.
- Installing sensors on the fingerboard latches with a type of interactive software that allows operators to verify latch position at a control panel and automatically prevent movement of the guide head when fingerboard latches are not in the correct position.
- Installing low pressure sensors that provide notification of an out of range condition or that automatically prevents movement of the guide head when low pneumatic pressure is detected at the fingerboard latch pistons.
- Installing strategically placed cameras near the pipe racking system for operator verification of the connection from multiple angles.
