A BSEE accident investigation Panel concluded that the causes of the fatality were as follows:

A **Safety Alert** is a tool used by BSEE to inform the offshore oil and gas industry of the circumstances surrounding an accident or a near miss. It also contains recommendations that should help prevent the recurrence of such an incident on the Outer Continental Shelf.

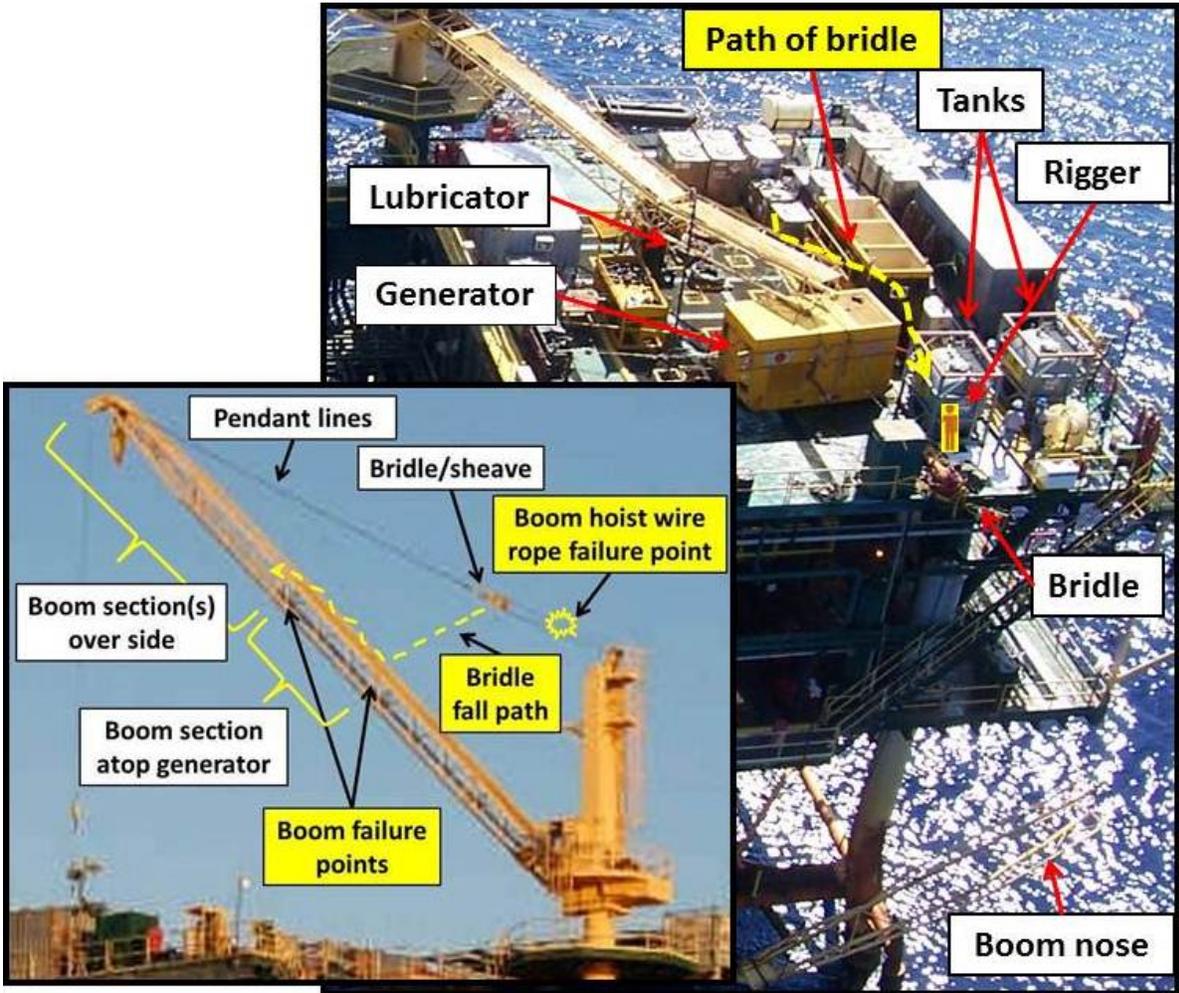
- (1) The Crane's boom hoist wire rope parted due to being weakened by advanced corrosion.
- (2) The vicinity of the lift was constrained by other equipment which caused the riggers to use tag lines to control the load, and to be positioned in the path of the falling boom. The positioning riggers in the case of a boom hoist wire rope failure was not considered during the JSA.

- (3) The crane's corroded boom hoist wire rope lacked internal lubrication; probably because of improper lubrication method, frequency, and an improper lubricant type.
