# SAFETY ALERT

Safety Alert No. 325  
18 October 2017

## Bolt Failures

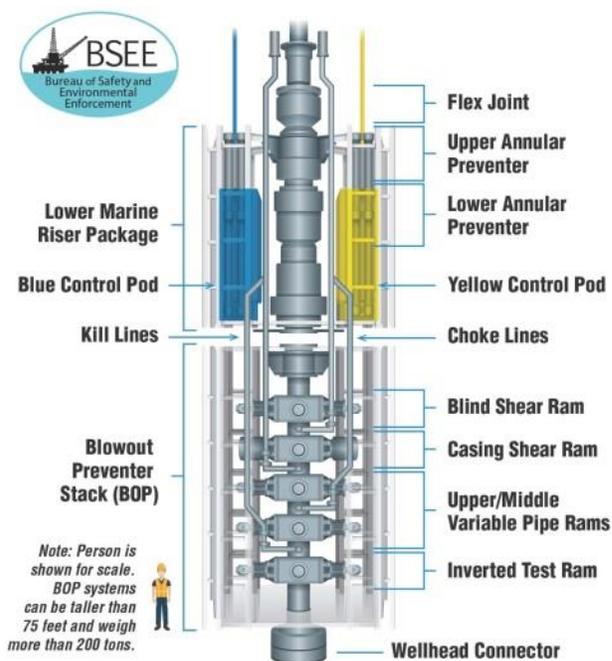
Generalized blowout preventer (BOP). This example is not meant to be indicative of the blowout preventer discussed in this Safety Alert.
