# Safety Alert

Safety Alert No. 301  
13 April 2012

## Fall/Fatality during P&A/Platform Abandonment: Supervision, Operational, Equipment, and Organization Errors

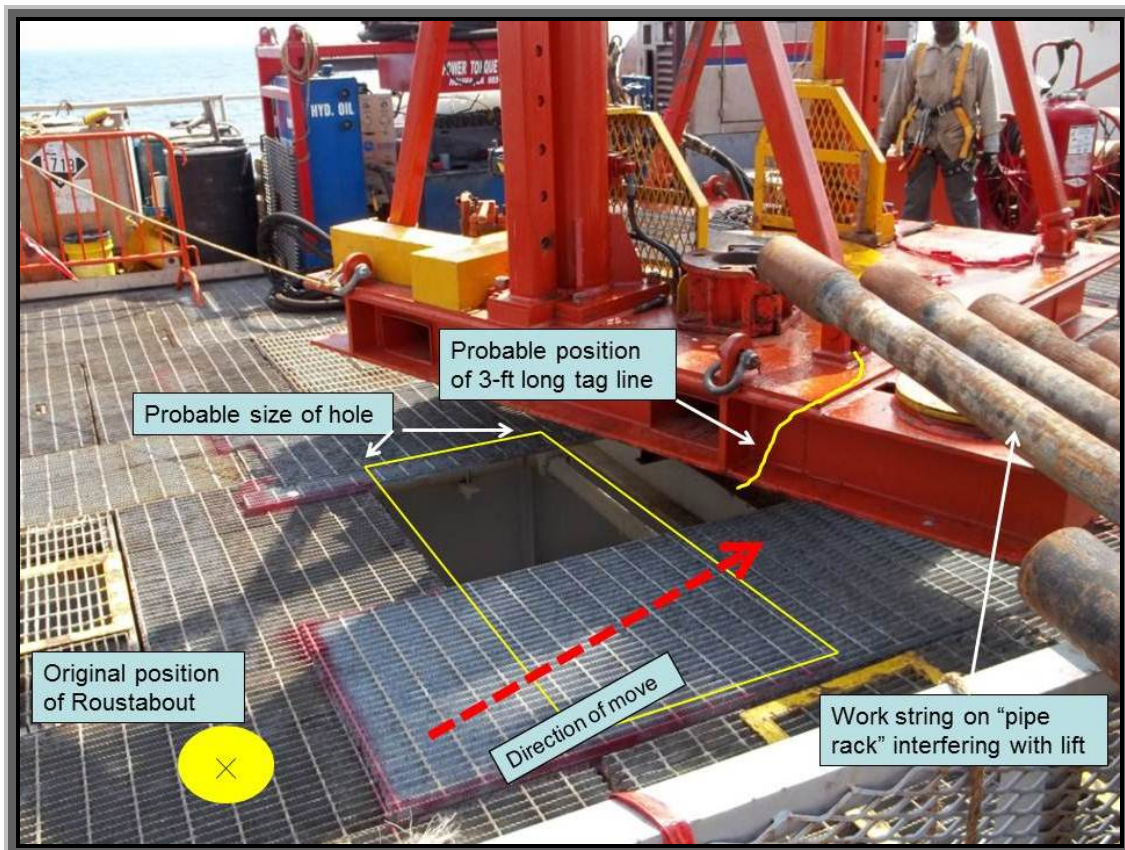
The accident occurred at night while the power swivel was being moved from atop the well with the roustabout acting as a rigger helping control the load. When the power swivel was lifted, the roustabout stepped, or was dragged by the load into the well-access opening in the deck that was exposed by the movement of the power swivel, and fell to his death. Night medevac callout was delayed due to confusion in emergency planning.

- The power swivel skid was equipped with two “tag lines” that were only three-feet long thus requiring the riggers to be in close proximity to the load. The tag lines were attached to the power swivel in such a way that they would drag across the open hole as the skid was moved;

- Medical evacuation procedures and contact should be prominently displayed and all crew members acquainted with that information and the procedures.
- P&A/platform decommissioning operations should have a comprehensive safety evaluation for the organization of multiple simultaneous tasks.
- A fully attended and comprehensive JSA that covers all the risks should be a requirement.
- Fall protection should be available and used in the presence of open holes, or if holes may be exposed in the course of an operation.

- A lift should be evaluated for all risks, and the appropriate tag lines, and use of tag lines, should be reviewed.
- Management and supervisors should insure the work space organization, availability of necessary equipment, proper positioning of equipment, and the conduct of operations, be fully and constantly reviewed for safety hazards before and during operations.
- Management should assign enough supervisors to P&A/platform decommissioning operations to allow direct, oversight of operations.
