SAFETY ALERT

Safety Alert No. 319
February 29, 2016

Chemical Injection Point Corrosion Causes Production Header Failure

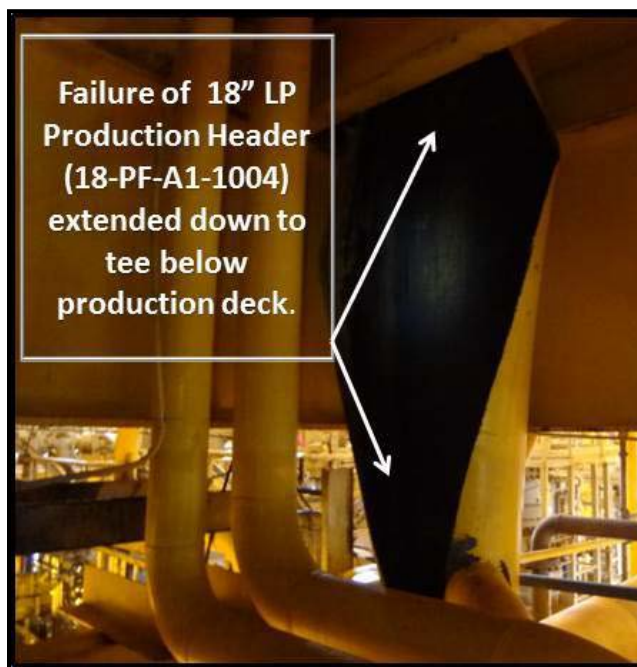
Recently, an 18-in low pressure production header on a producing platform in the Gulf of Mexico failed under normal working pressure. The failure ruptured the header, opening a 10-ft long split and releasing production fluids at a pressure of 250-psi. Three workers were sprayed with production fluid and approximately 25 bbls were released. The event resulted in the evacuation of the platform.

An investigation by BSEE concluded the failure was caused by a corrosive loss of pipe integrity immediately beneath a chemical drip injection point used to introduce an acidic demulsifier into the flow stream. Over time the demulsifier corroded away approximately 50-percent of the metal thickness of the pipe below the injection point.

BSEE concluded that the proper procedure would have been to inject the acidic demulsifier into the pipe using an injection quill. The injection quill would have introduced the demulsifier into the middle of the flow stream keeping it from continually impacting the pipe wall in proximity to the injection point.

BSEE recommends that Operators develop procedures ensuring the proper use, installation, and verification of chemical injection equipment. We also recommend that Operators conduct both visual and non-destructive testing of all corrosive chemical injection points to verify that the recommended injections quills are installed and that the existing piping has not been compromised by the injection process.
