# SAFETY ALERT

**Safety Alert No. 328**  
**January 5, 2018**

## **Gas Release Hazards Identified by BSEE**

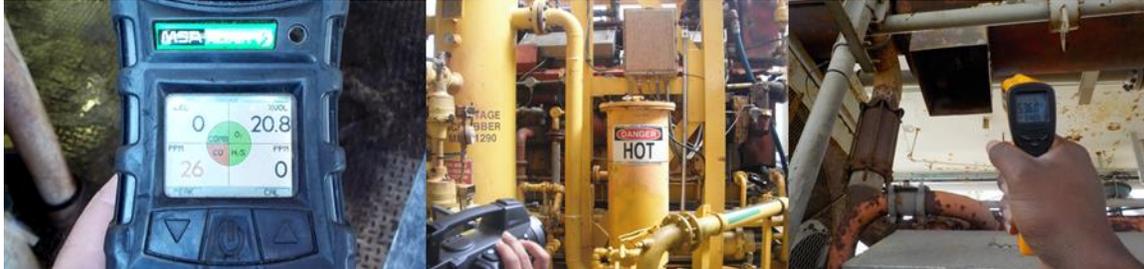
*BSEE inspectors use hand-held gas detectors, thermal cameras, and infrared thermometers during gas release risk inspections.*
